AVIATION INVESTIGATION REPORT

A00P0009

OPERATING IRREGULARITY

BEECH 1900D C-FCMP

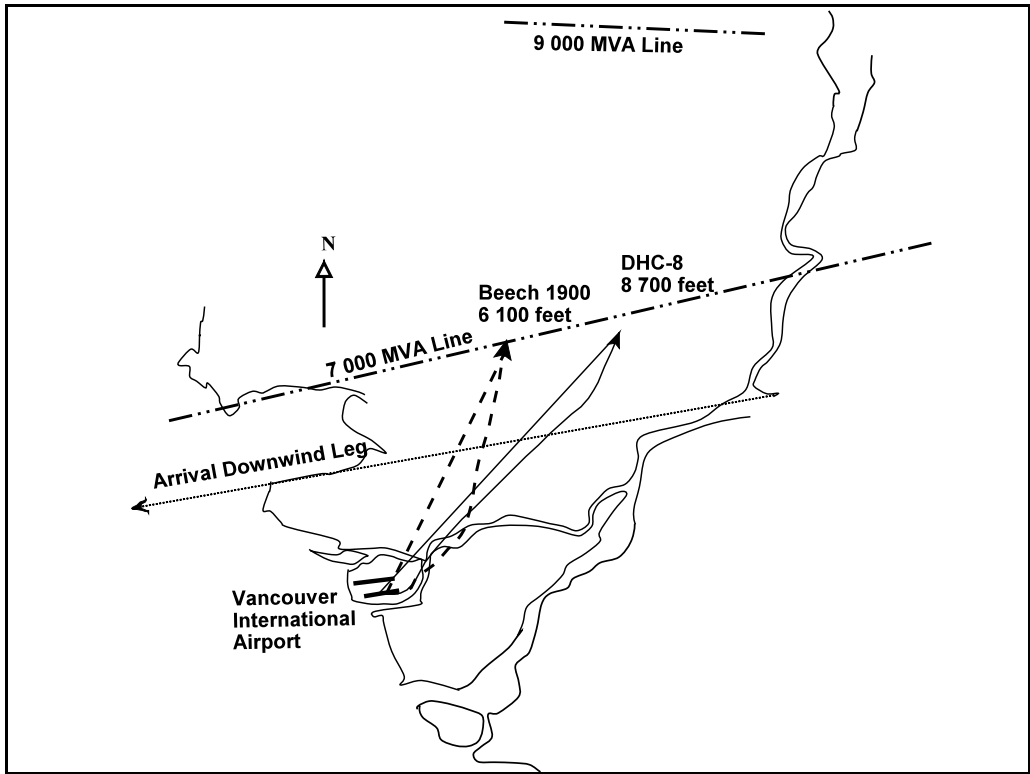
When the first departure controller detected the Beech 1900D entering the 7000-foot MVA sector at 6100 feet, he issued a 080 heading to turn the aircraft away from the higher terrain and parallel to—but still within—the sector boundary. He then requested that the aircraft increase the rate of climb. MANOPS requires controllers to “issue a safety alert to an aircraft if you are aware the aircraft is at an altitude which, in your judgment, places it in unsafe proximity to the terrain, an obstruction or another aircraft.” One optional example of phraseology to be used is: “The minimum IFR altitude in your area is [altitude]. Altimeter setting is [setting].” The pilot of the Beech 1900D was not made aware that he was below the required MVA during the incursion of the 7000-foot MVA sector at 6100 feet or during the later incursion of the 9000-foot sector at 8400 feet. The TSB has previously made findings and issued a Safety Advisory Letter (see TSB Report A96P0293) on the lack of use of safety alert phraseology by controllers.

The first departure controller's experience led him to believe that a Beech 1900D on departure from runway 08 right, given a vector of 010 degrees when through 3000 feet, would easily achieve the altitude levels necessary to meet the MVA to the north of Vancouver. In this occurrence, aircraft climb performance varied from what was expected by the controller. The need to attend to a separation problem to the south of Vancouver, an area designed to be controlled by another controller, diverted the first departure controller's attention for a short time. The distraction was long enough to allow the aircraft's climb rate and high forward speed to place it inside the boundary of the 7000-foot MVA before the first departure controller noticed it.

Figure 1. Beech 1900D penetrates 7000 feet MVA at 6100 feet (not to scale).

Immediately following this occurrence, Vancouver ACC and tower management issued direction to controllers cancelling the POCO ONE SID until a review of the SID and all associated procedures could be completed. Tower controllers will ensure that propeller aircraft departing runway 08 right northbound will be assigned runway heading and will not be turned immediately toward the higher terrain to the north of Vancouver.

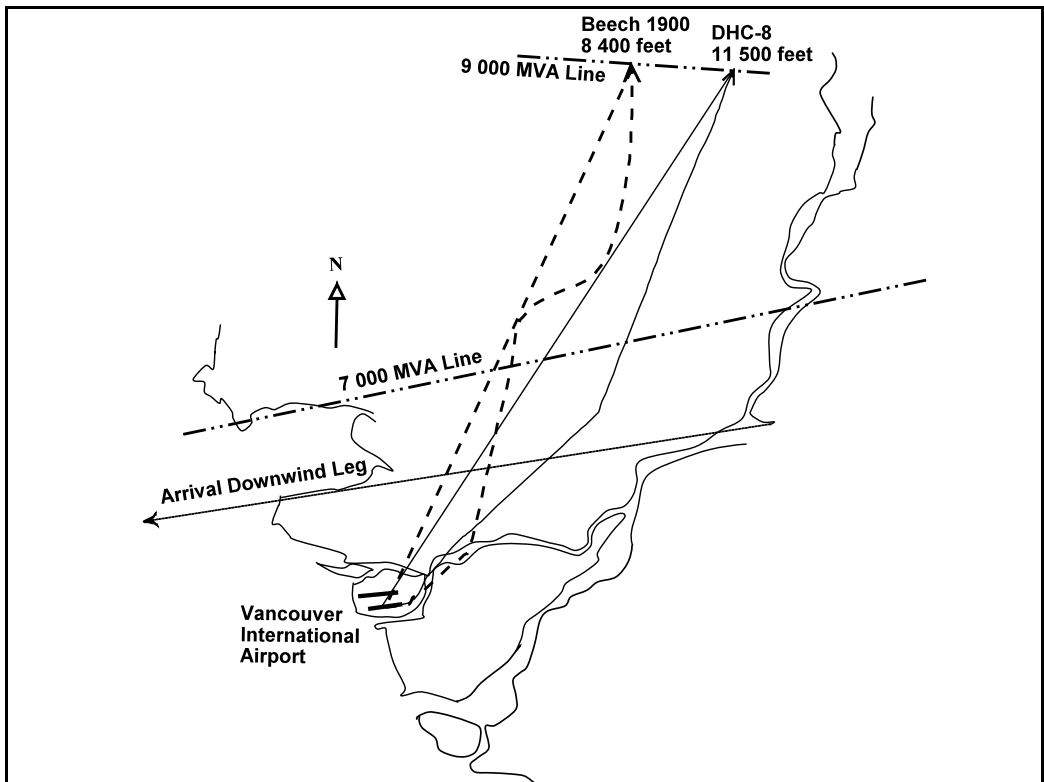
After the Beech 1900D regained the cleared level at 8000 feet, and when it was approximately two miles from the 9000-foot MVA boundary, the second departure controller issued a further climb clearance to 11 000 feet. He then immediately transferred his attention to traffic that had just departed from Vancouver en route to the south. The incursion by the Beech 1900D into the 9000-foot MVA at 8400 feet was detected the next day during review of the radar tapes.

When the second departure controller cleared the Beech 1900D to climb to 11 000 feet only two miles from the 9000-foot MVA boundary, he expected the aircraft to be able to meet the altitude requirements. Again, traffic to the south distracted the controller, and he was not aware that the Beech 1900D had penetrated the 9000-foot MVA below the required altitude.

1. The second incursion of the Beech 1900D into a 9000-foot MVA sector below the minimum IFR altitude was not detected until radar tapes were reviewed the day after the occurrence.

Figure 2. Beech 1900D penetrates 9000 feet MVA at 8400 feet (not to scale).
